X-RAY RADIOGRAPHY OF GAS TURBINE CERAMICS

Technical Report By:
D. J. Cassidy, M. F. Elgart
Ford Motor Company,
Dearborn, Michigan 48121

Date: October 20, 1979
Annual Report No. 1
October 1, 1978 to September 30, 1979
Contract Number N00014-78-C-0714
Contract Authority Number NR032-590/6-28-78 (471)

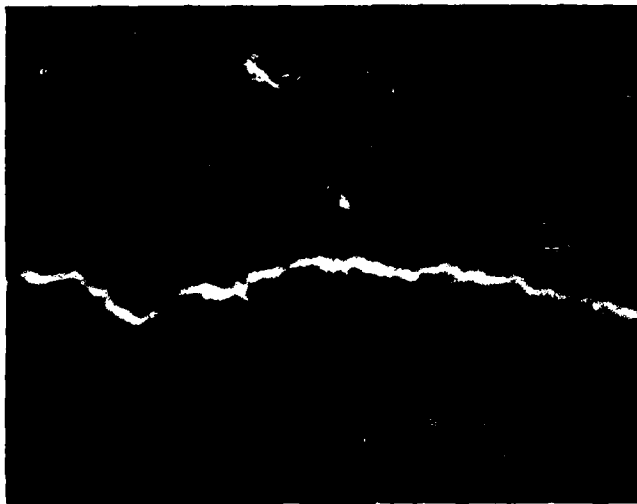
37 X

270 X

Figure 14. Surface Crack of Rotor Blade 14.

Visual inspection with a low-power stereo magnifier of the rotor blades showed some surface cracking. A closeup of one of these surface cracks is shown in Figure 14. This crack is approximately 6-11 microns wide and 1.75 mm in length. The magnified radiograph of this blade and its image enhancement could not discern this crack, although microdensitometer readings over the area where the crack should be indicated some small change in film density. It is to be anticipated that CAT will be a more effective way of detecting these linear cracks in that, at some angle of view, when the crack is parallel to the beam, an increased beam intensity could provide an adequate means for detection.
